# Mobile Intel<sup>®</sup> Pentium<sup>®</sup> II Processor Specification Update

Release Date: June 2002

Order Number: 243887-041

The Mobile Pentium<sup>®</sup> II processor may contain design defects or errors known as errata which may cause the product to deviate from published specifications. Current characterized errata are documented in this Specification Update.

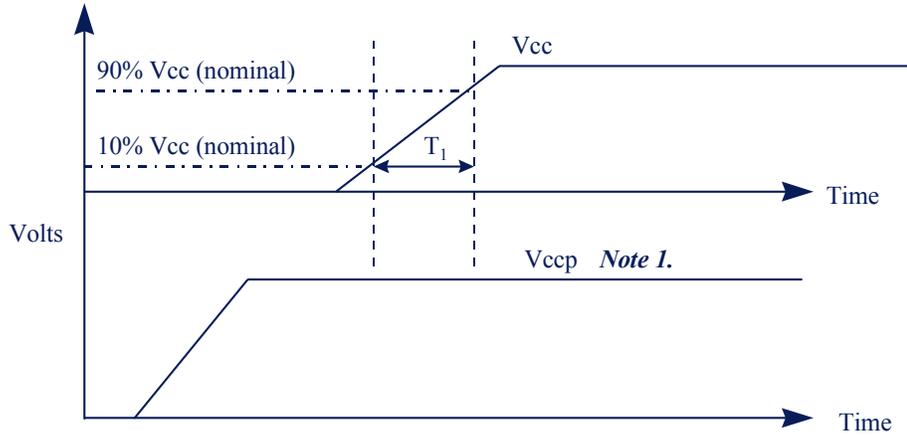
**Problem:** The processor uses the PWRGOOD signal to ensure that no voltage sequencing issues arise; no pin assertions should cause the processor to change its behavior until this signal is asserted, when all power supplies and clocks to the processor are valid and stable. However, if  $V_{CC}$  ramps up before  $V_{CCP}$ , it will cause the processor to enter an invalid state.

**Implication:** If this erratum occurs, the system may boot normally however, the L2 cache may not be initialized.

**Workaround:** For Mobile Pentium II processors, ensure that  $V_{CC}$  ramps after or with the L2 cache IO voltage ( $V_{CCP}$ ). If  $V_{CCP}$  ramps after the  $V_{CC}$ , a delay circuit can be placed on the core  $V_{CC}$  to ensure that  $V_{CC}$  ramps at the same time or after  $V_{CCP}$  as shown below in Figure 1.

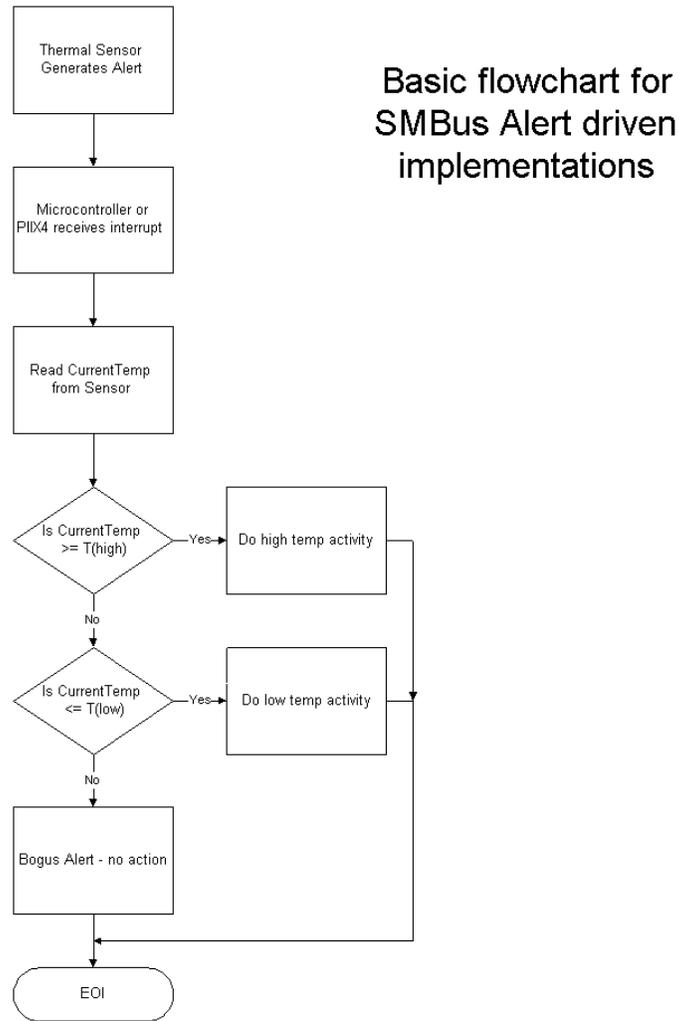
Figure 2. Workaround Flowchart: SMBALERT#-Driven System

### B30. Thermal Sensor May Assert SMBALERT# Incorrectly

Under the conditions described below, the thermal sensor incorrectly generates the SMBALERT# interrupt. All of the following conditions must be met to trigger a false interrupt:

1. Before servicing an interrupt from the thermal sensor, read and compare the processor thermal reading with the threshold limits ( $T_{HIGH}$  or  $T_{LOW}$ ). Figures 2 and 3 provide basic flowcharts for the implementation of this workaround in an interrupt driven system.
2. If the firmware implemented polls the Status Register only, then before taking any action, re-read the temperature register and do a comparison with the alarm threshold limits ( $T_{HIGH}$  or  $T_{LOW}$ ) to determine if the value is actually still within the temperature window.
