# Mobile Intel<sup>®</sup> Pentium<sup>®</sup> II Processor Specification Update

Release Date: June 2002

Order Number: 243887-041

The Mobile Pentium<sup>®</sup> II processor may contain design defects or errors known as errata which may cause the product to deviate from published specifications. Current characterized errata are documented in this Specification Update.

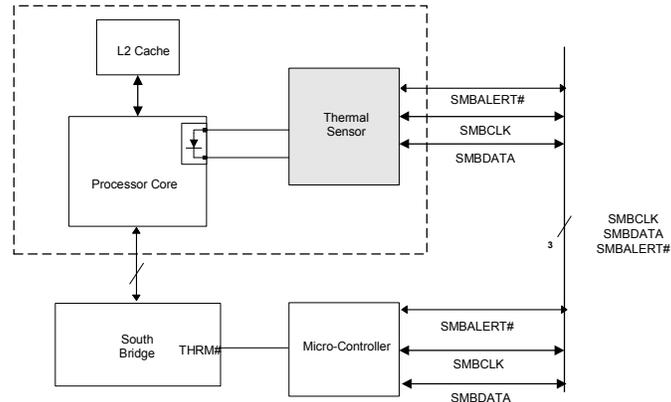
**Figure 1. An Example of Microcontroller Driven Thermal Management**

### B30. Thermal Sensor May Assert SMBALERT# Incorrectly

**Problem:** The Mobile Pentium II processor and the Pentium II Processor Mobile Module have a thermal sensor that monitors the processor core's temperature. Please note that desktop systems could have a similar thermal device. The thermal sensor asserts SMBALERT# if the processor temperature exceeds the temperature limits set in the Alarm Threshold Registers ( $T_{HIGH}$ ,  $T_{LOW}$ ). It also sets the corresponding Status Register bits to identify the cause of the interrupt. Figure 1 gives one example of the how the SMBALERT# signal could be used in a system.

Under the conditions described below, the thermal sensor incorrectly generates the SMBALERT# interrupt. All of the following conditions must be met to trigger a false interrupt:
